Architectural Design Review Board
March 7, 2023 @ 4:00 p.m.
Council Chambers
First Floor, 345 High Street
Hamilton, Ohio 45011

To: Architectural Design Review Board
From: Dani Baxter
Subject: **New Business - AGENDA ITEM #1**
29 S D St- Window Replacement
Brian Marischen, Applicant
Meeting Date: March 7, 2023
Received Application: February 13, 2023
Impacts: Rossville-Main Historic District

The Applicant, Brian Marischen, has submitted a Certificate of Appropriateness Application for window replacement proposed at 29 S D Street. The proposal involves replacing three (3) historic wood windows with Anderson 400 windows with exterior muntins.

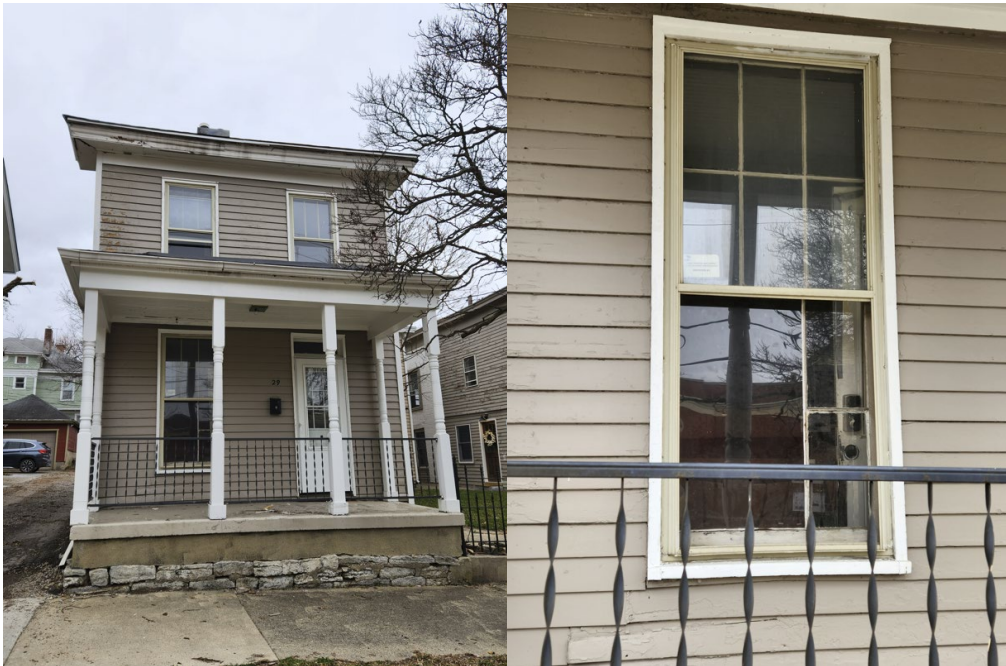
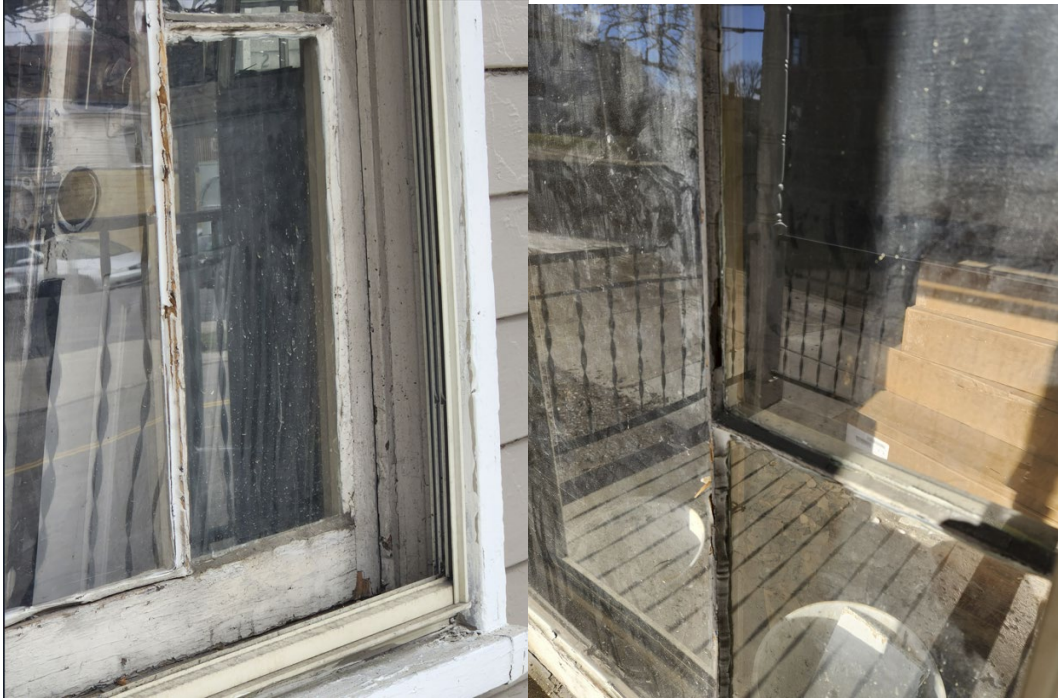
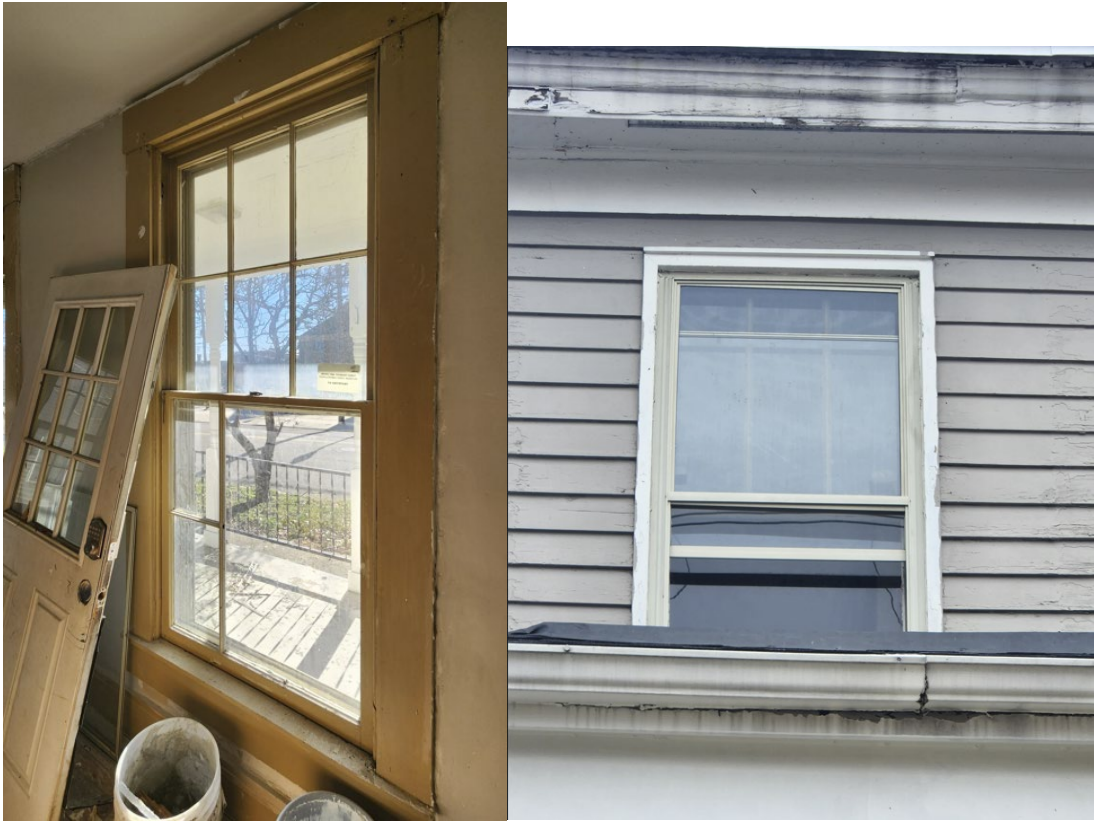
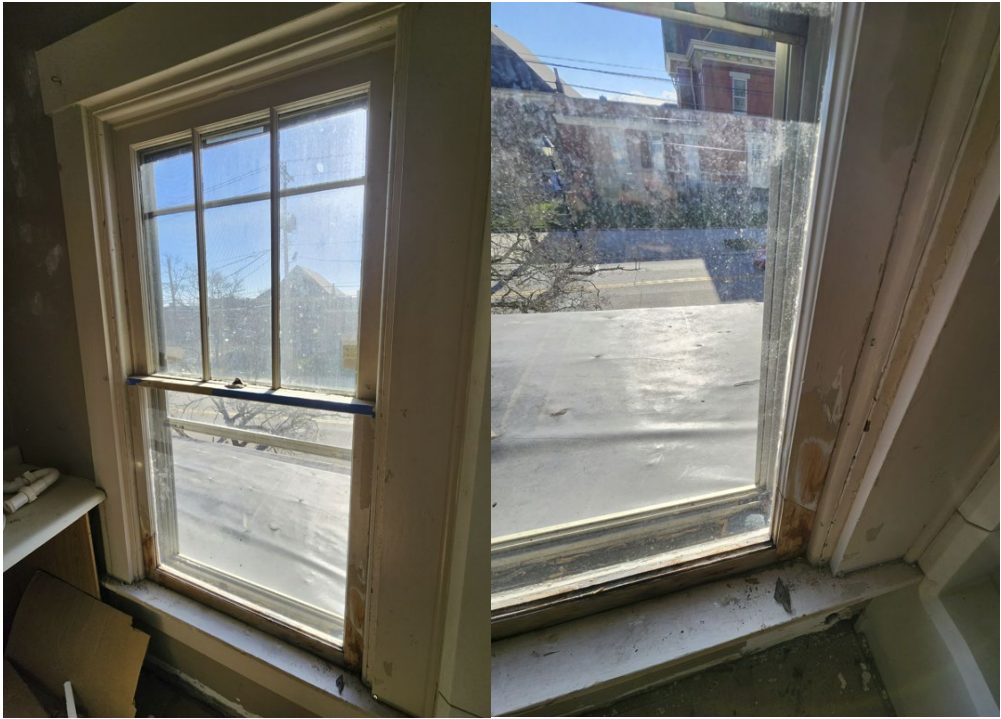
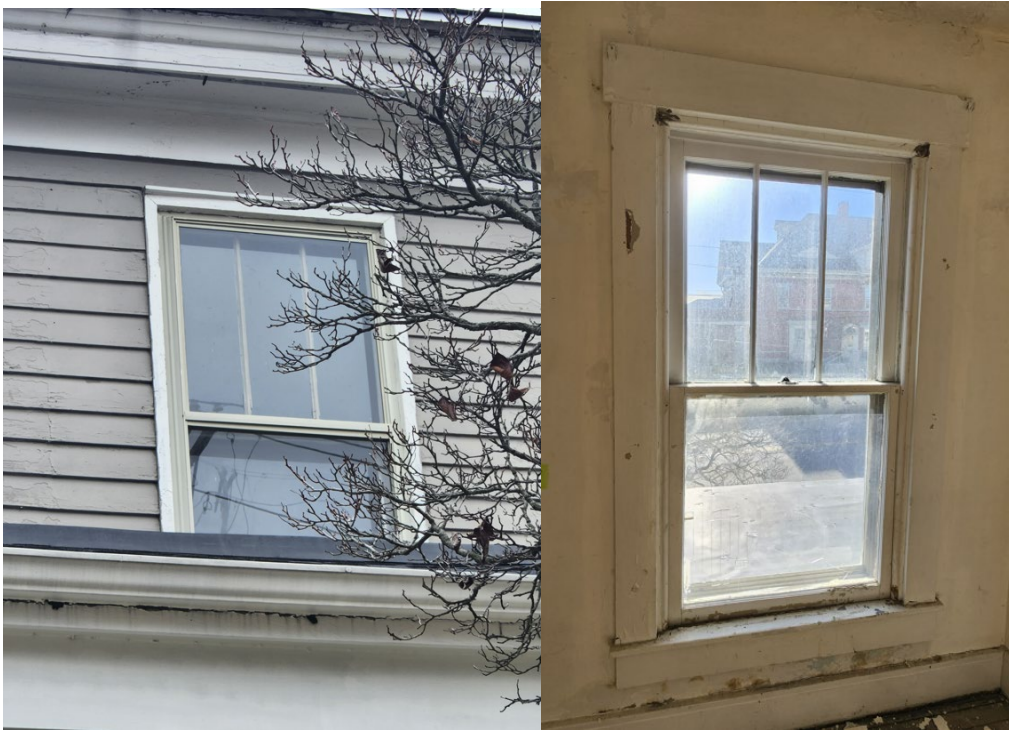
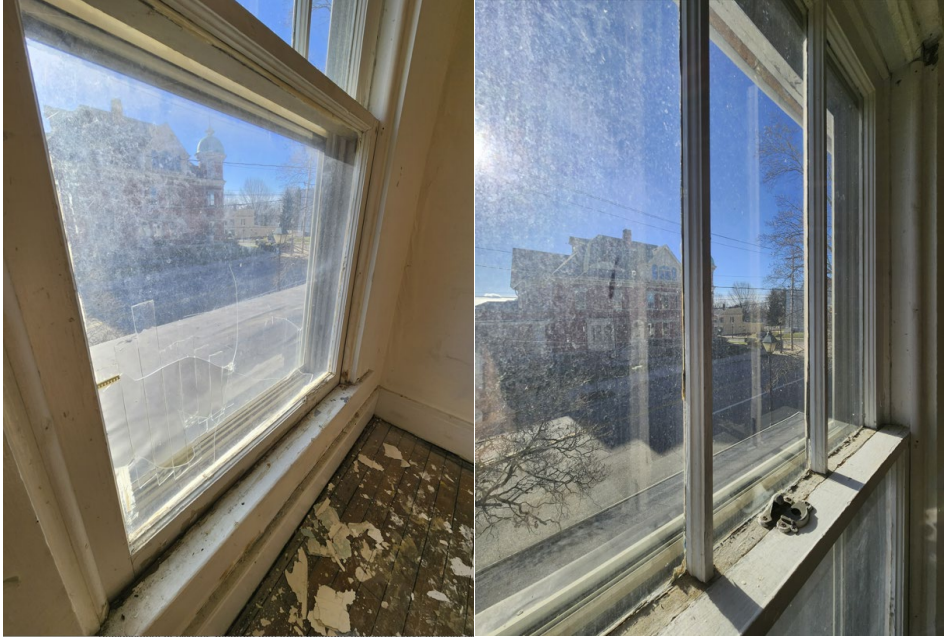
Front Façade Windows

1. Planning Department staff met with the applicant on site to assess the extent of the damage on the three (3) wood windows that appear to be original. There is one (1) window that appears to be salvageable and two (2) windows that are missing muntins and have Plexiglas installed as replacement for

- broken windowpanes. It is unknown if the mechanics of the window are operational.
2. There is one window that appears to be original with the possibility of being repaired but it does not fit any window openings on the front façade. The window would be eight (8) inches too tall and two (2) inches too narrow for the first floor, front façade window opening.
