Planning Department 345 High Street, 3rd floor Hamilton, Ohio 45011

> Architectural Design Review Board May 16, 2023 @ 4:00 p.m. Council Chambers First Floor, 345 High Street Hamilton, Ohio 45011

- IV. <u>Old Business Properties Seeking COAs</u>
 - 1. <u>10 Kirk Ave (Ohio Historic Inventory) Window and Door Replacement,</u> <u>Work Without a COA</u>

| То: | Architectural Design Review Board |
|---|---|
| | 10 Kirk Ave – Window and Door Replacement, Work Without a COA |

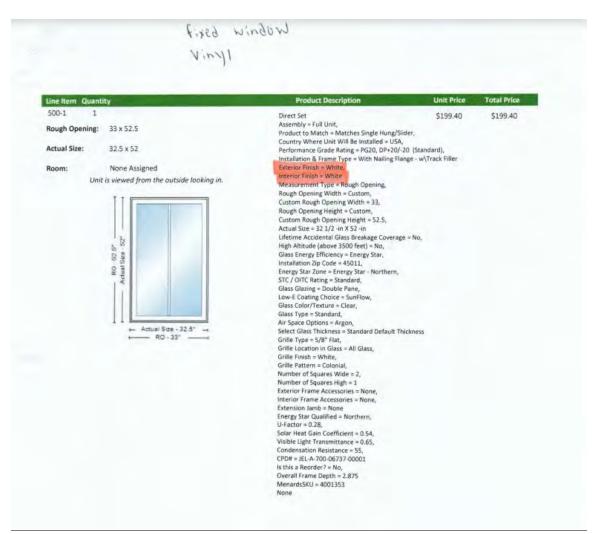
New window proposal- Jeld Wen

Applicant also stated that he has another option for the front façade windows. This option would be comprised of installing two Jeld Wen, fixed vinyl windows, stacked on top of each other within the existing opening. There appears to be a single vertical muntin in the window. The applicant also noted that there are other windows within this room that can be used for ventilation.

Jeld Wen, Good Series windows are not on the approved list of replacement windows.
